# PEATLAND REHABILITATION EFFORTS IN NORTH SELANGOR PEAT SWAMP FOREST

Faizal Parish<sup>1</sup>, Nagarajan R.<sup>1</sup>, Mohd Puat Dahalan<sup>2</sup>, S.Y. Lew<sup>1</sup>, Julia Lo<sup>1</sup> and Noor Azura A.<sup>1</sup>

<sup>1</sup> Global Environment Centre, Petaling Jaya, Malaysia. (nagarajan@gec.org.my)

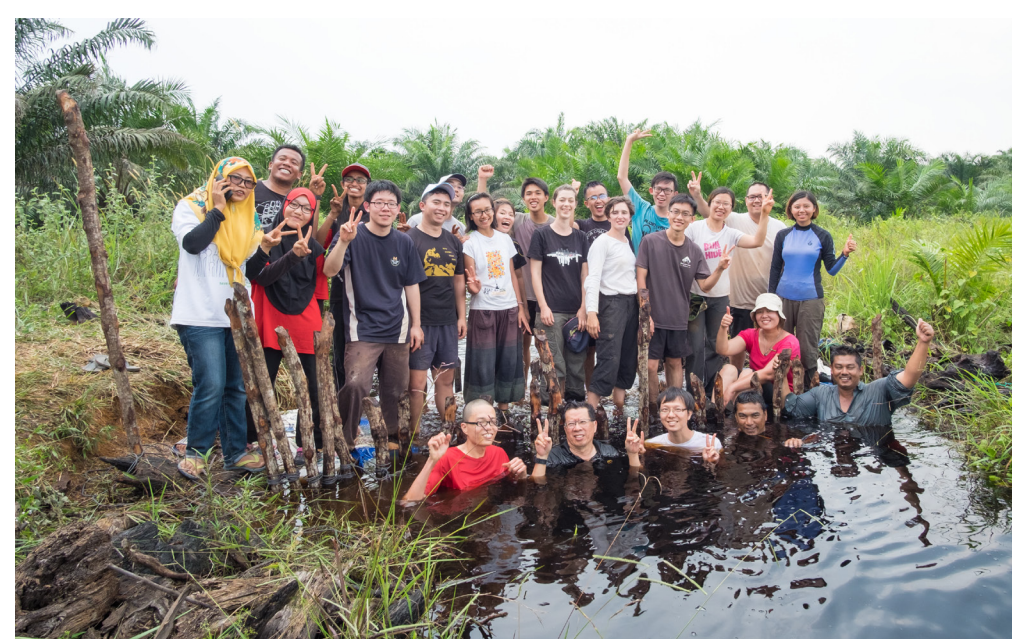
### 1. HYDROLOGY RESTORATION / REWETTING

The first step in rehabilitation is to stop drainage and restoring hydrology of the degraded site. This is achieved by detailed mapping of the drainage network, identifying the outlet points; building canal blocks at major outlet point and appropriate points (100-1,000m apart depending on the slope) along the drains and quickly establishing ground cover to improve the soil moisture.

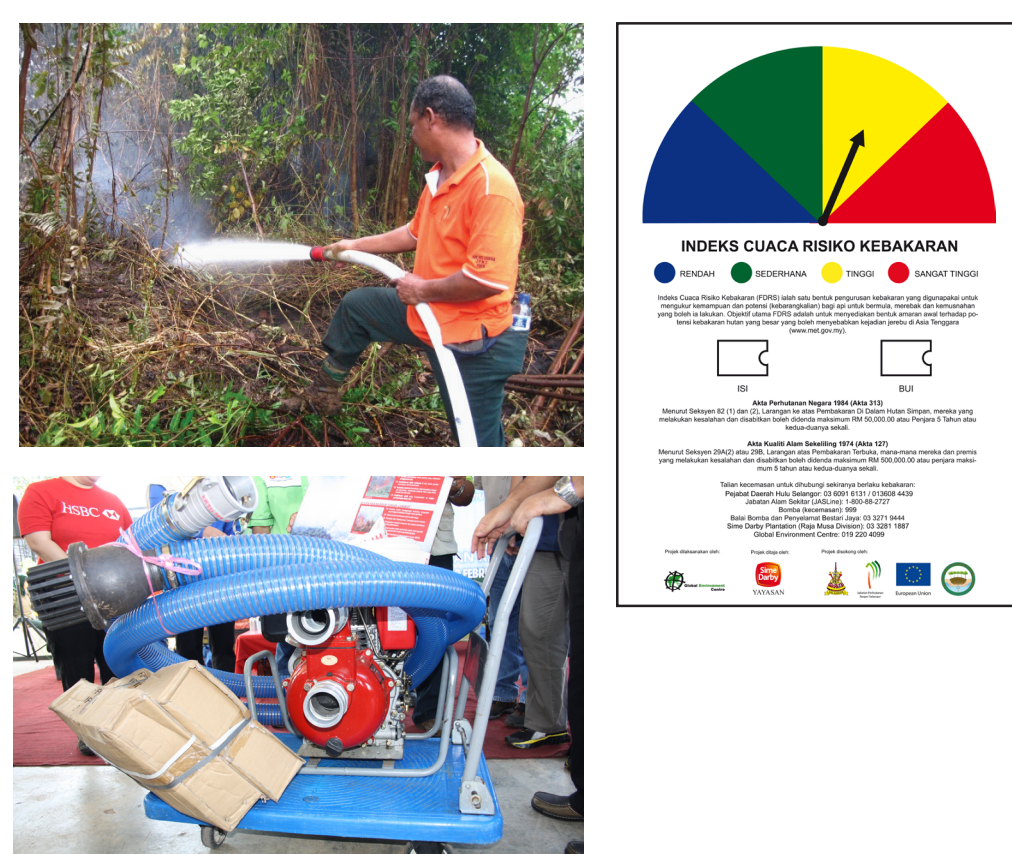
### 2. FIRE PREVENTION AND CONTROL

Fire prevention needs to be done both in the forest reserve and the adjacent lands. Water table should be raised in line with the first strategy in all fire prone areas. The fire risk should be reduced through coordination with adjacent land owners. Regular patrolling and monitoring should be undertaken of all rehabilitation sites to detect any disturbance and identify any fires in adjacent areas. Any fires should be quickly put out through a coordinated effort from different agencies.

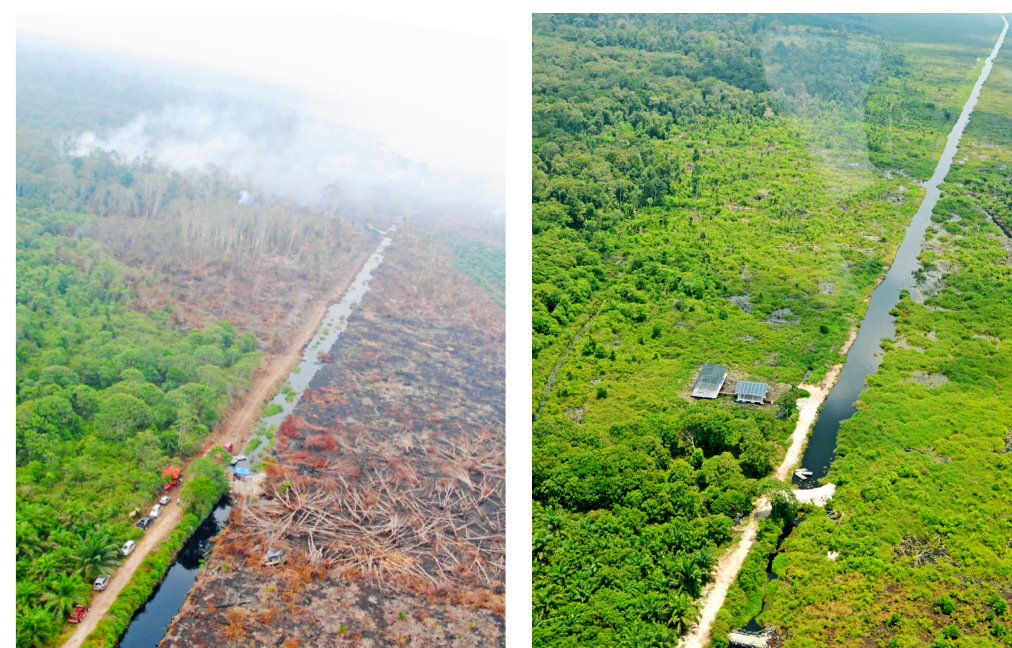
### 3. ENCOURAGE NATURAL REGENERATION

This is suitable in areas where the degraded area is relatively small and surrounded by forests which provide options for easy seed dispersal. In addition the water level should be relatively high and the area safe from fires. In these circumstances the areas can be left to regenerate naturally with periodic monitoring.

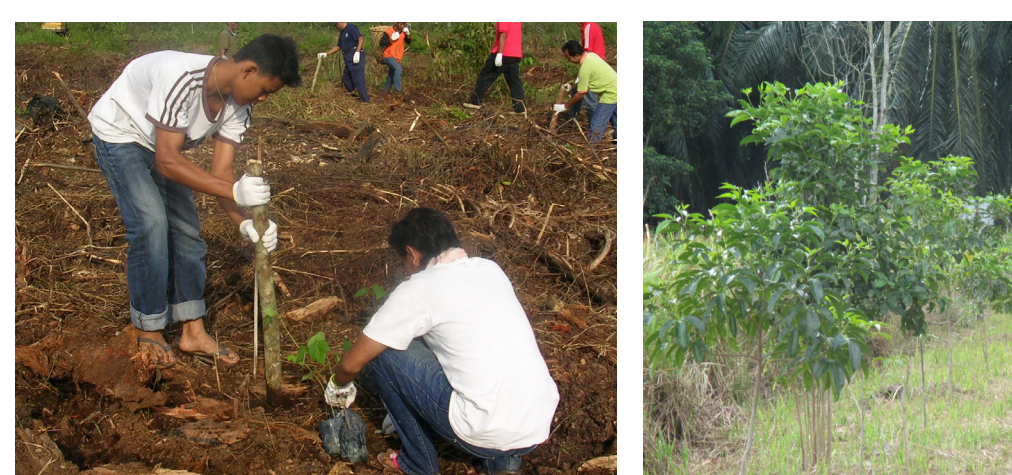
### 4. ASSISTED RE-VEGETATION

Smaller degraded areas can assisted to rehabilitate naturally by providing suitable planted materials (avoid non peat swamp forest species), planting pioneer species in open areas and regular maintenance.

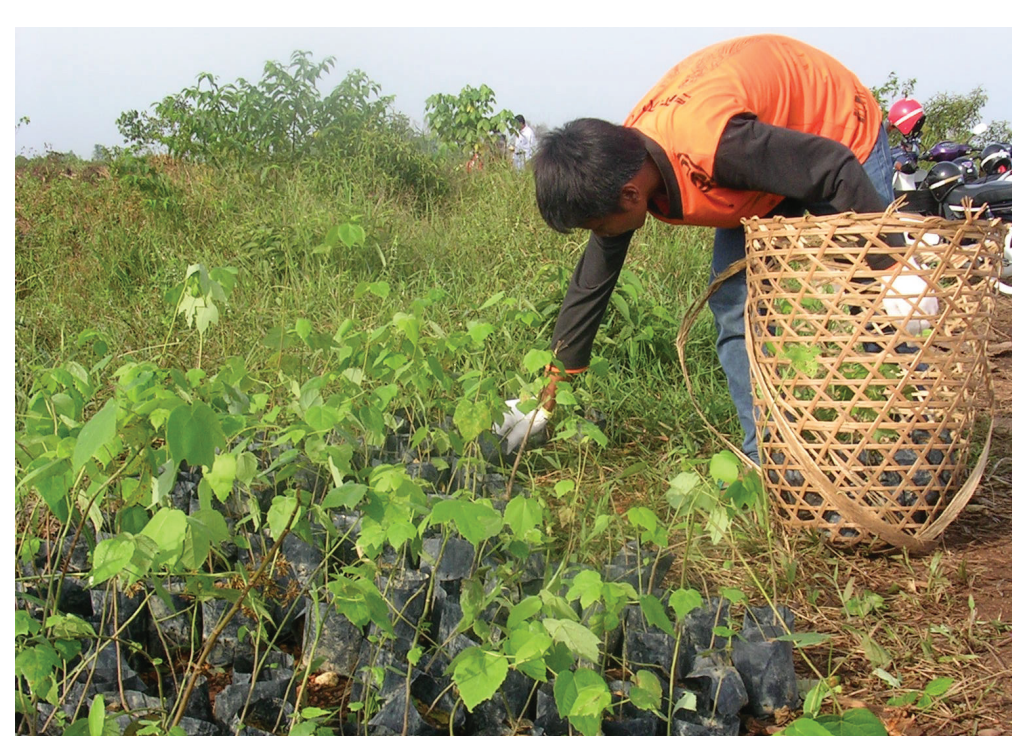
### 5. ENRICHMENT PLANTING

Areas dominated by single pioneer species eg. Mahang (*Macaranga pruinosa*) or Tenggek Burung (*Euodia ridleyi*) should be enriched with other species to increase flora diversity. Forest species such as Mersawa Paya (*Anisoptera marginata*) Ramin (*Gonystylus bancanus*) and others high quality peat species can be planted and maintained to increase survival rate.
